**Condition of Chromated Copper Arsenate Treated Hem-fir Guardrail Posts after
20 Years in Service in Western Washington State**

A Final Report Submitted To

Western Wood Preservers Institute

November 2012

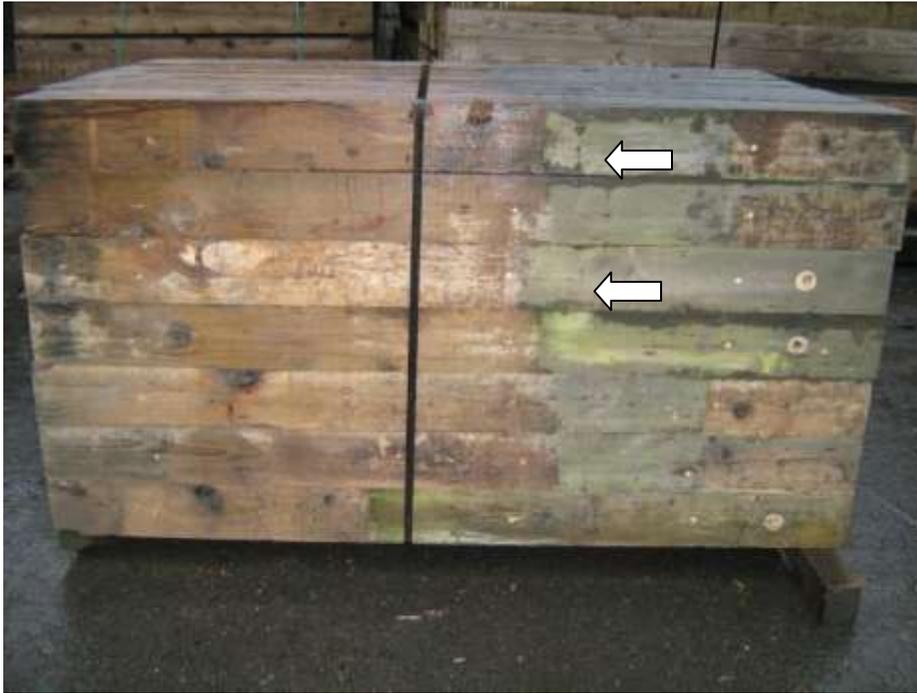
Figure 1. Example of a bundle of used guardrail posts after sampling. Arrows show locations where increment cores were removed

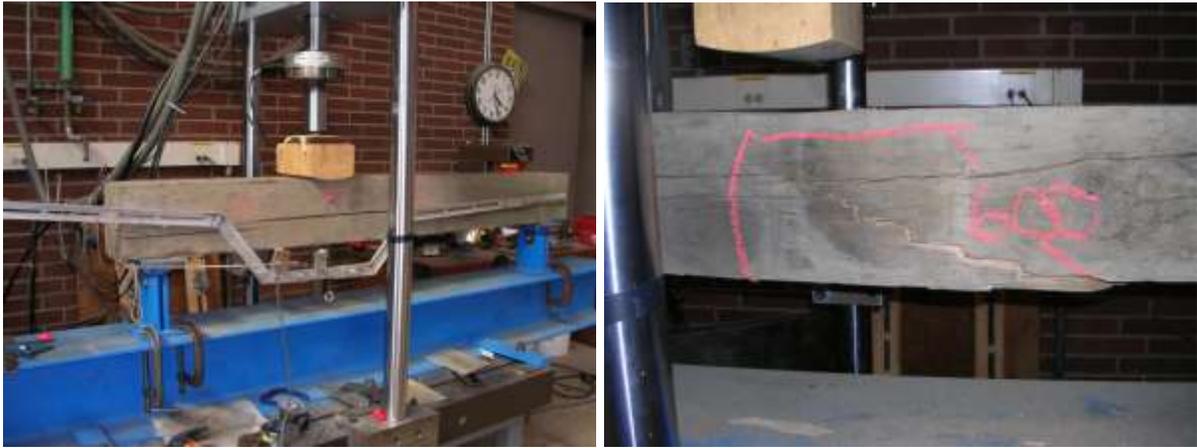
Figure 2. Examples of a guardrail post in test and a close-up showing a tension failure after testing.

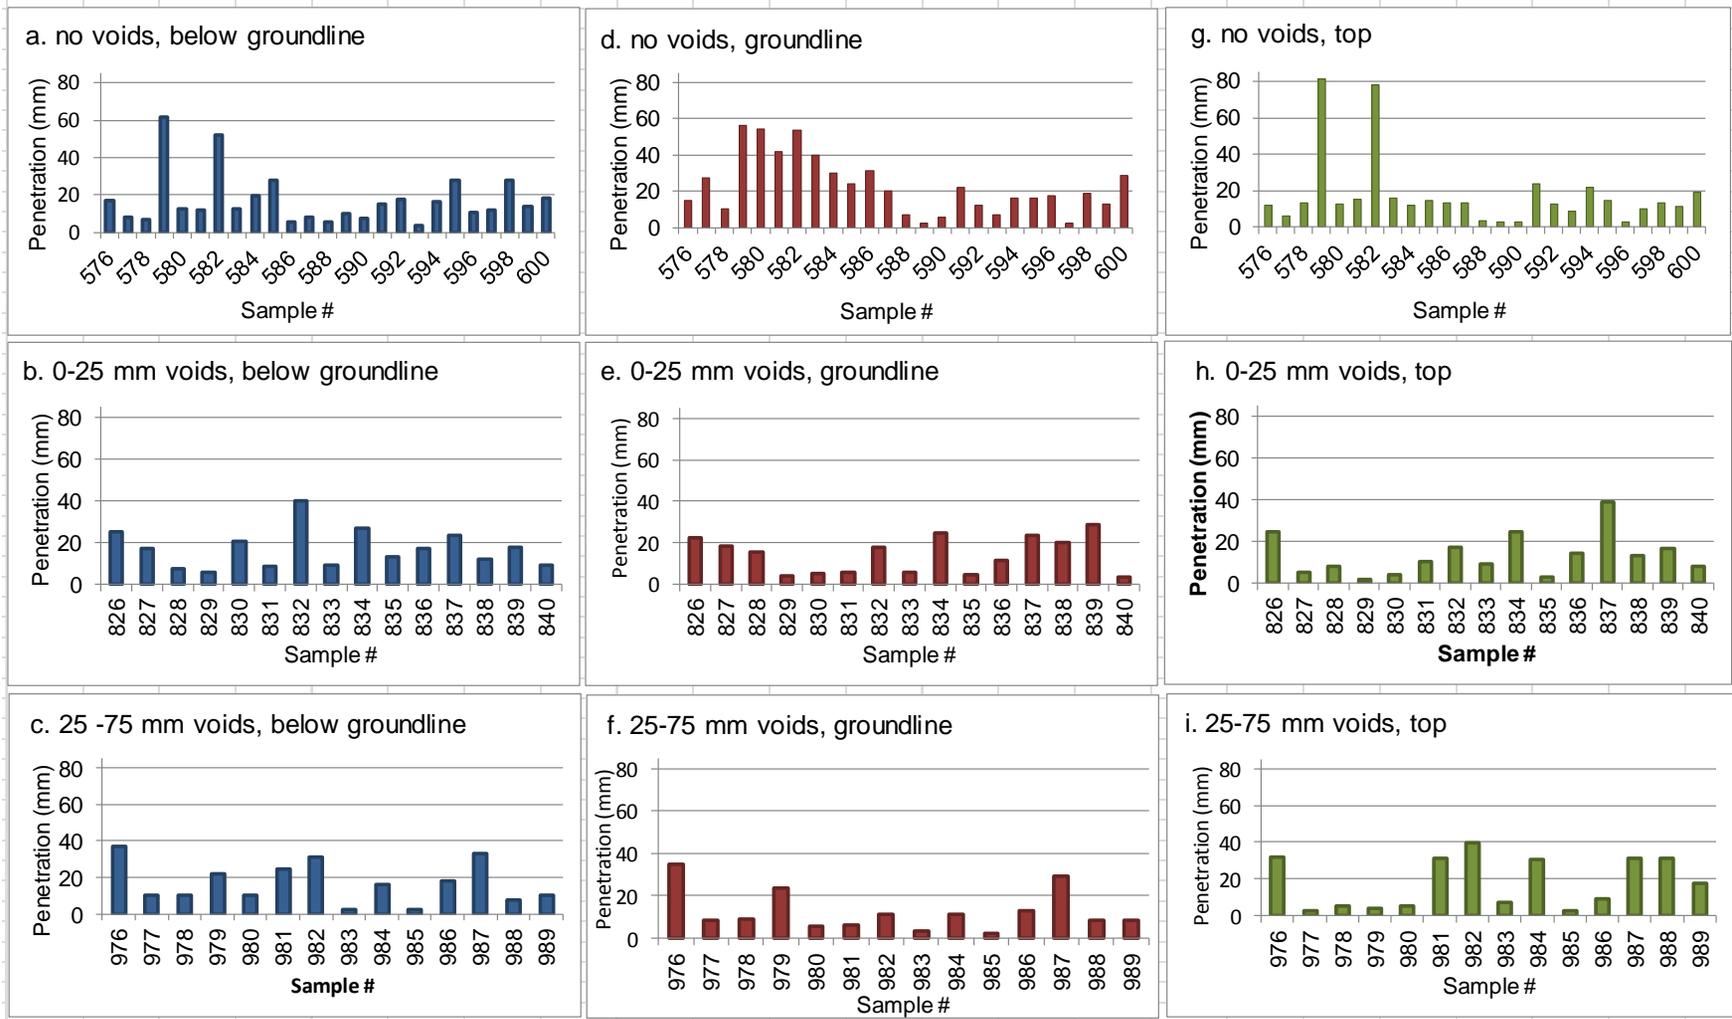
Average depth of preservative penetration in the in-service posts ranged from 14.8 to 19.3 mm (Table 1). Penetration was generally above the minimum of 10 mm required in the AWPAs Standards. However, penetration was below the minimum in a number of posts, especially those with some level of internal decay. Only 5 of 25 posts with no evidence of voids failed to meet the minimum penetration level, while 6 of 15 posts with a void less than 25 mm deep and 8 of 14 posts with voids that were larger than that failed to meet the penetration level (Fig. 3). Moreover, shallower average penetration depth was associated with a significant negative influence on the presence of decay ($\rho=0.03$, ANOVA). These numbers must be viewed with caution since the initial selection process was designed to identify posts with defects in certain ranges. As a result, the relative percentages of defects present in the overall population are not representative. However, the results do illustrate the relationship between preservative penetration and decay and illustrate the importance of adhering to the AWPAs Standard for this material.

Posts with shallow penetration were significantly correlated with the presence of internal decay. This is consistent with the function of the treatment as an envelope of protection. Thinner barriers are more likely to be compromised through the development of seasoning checks over time. The initial sampling pattern was designed to select posts with some level of decay and it sometimes proved difficult to find many posts with decay pockets in the desired size range. The results suggest that a properly treated post should be largely resistant to fungal attack and that most of the posts met these criteria. These data are consistent with long-term trials of posts at Oregon State University (Morrell et al., 1999).

Figure 3. Preservative penetration in guardrail posts with no voids, voids of 0-25 mm, and voids of 25-75 mm at below ground line (a-c), at ground line (d-f) and top (g-i) portion of guardrail posts.

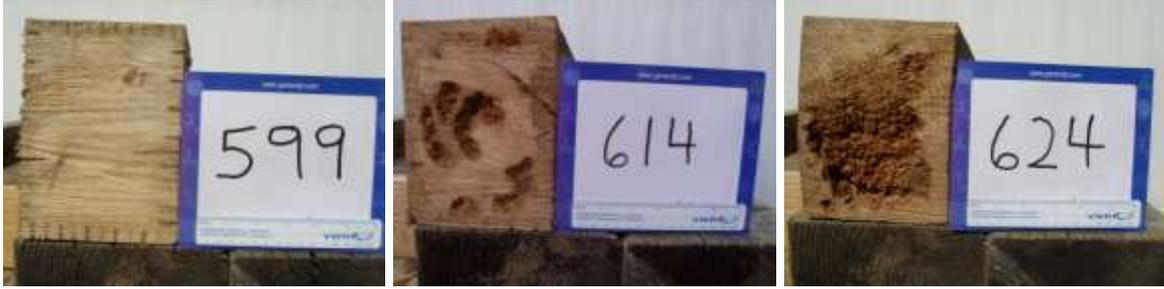
similar but slightly higher correlation was observed between the extent of decay observed on cross section cut after testing and MOR ($r^2 = 0.35$) (Fig. 6). The low correlation reflects the inherent high coefficient of variation for wood properties that poses a challenge for any regression models. Decay development is also variable and this variability further reduces the ability to relate wood properties with post condition. Examples of typical severity of decay are presented in Fig. 7. All the pieces were also visually graded for the extent of decay and classified into decay in the central zone, i.e., $\frac{1}{4}$ height below and above the geometrical center of the beam, and Edge zone is the $\frac{1}{4}$ from top and bottom. Decay in the central zone was associated with significantly lower MOR values ($p < 0.05$), while decay in the edge zone did not influence the MOR values. This is counterintuitive, as decay in extreme fiber should lead to decreased MOR values. Contrastingly, the extent of decay in the central or edge zones, did not significantly affect MOE.

(a) no decay

(b) small decay pocket

(c) large decay pocket

Figure 7. Examples of cross sections cut through the failure zones on CCA treated guardrail posts with no decay, and small vs. large decay pockets
