# Treated Wood Aquatic Case History

**MARK O. HATFIELD MARINE SCIENCE CENTER  
OREGON STATE UNIVERSITY**

## **Inspection Finds Creosote Treated Piling Sound After 28 Years Of Service.**

**PROJECT:** OSU Research Vessel  
Dock & Trestle Expansion  
Newport, Oregon

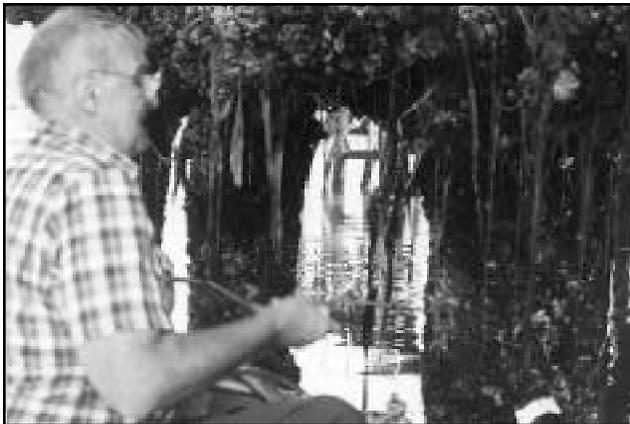
**RESULTS:** All cores had sapwood penetration of 100%; retention below the tide line was 21.38 PCF and 17.34 PCF above the tide line.

*TPI inspectors pull test cores to check penetration and retention levels.*

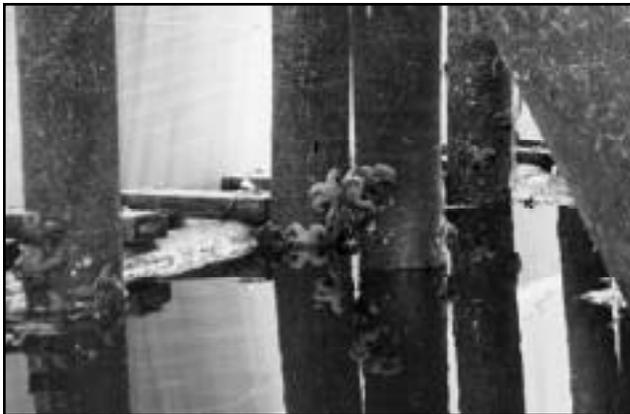
The piling inspected and bored appeared to be in excellent shape and continue to support the dock and trestle platforms. Out of all 119 piling that supported this project, only one needed replacing. That pile was damaged by mechanical abrasion and not product failure.

*The piling were heavily encrusted with starfish, sea anemones, mussels and other varieties of sea life.*
