# **Final Report**

## **Performance of Selected Wood-Protection-Coated Lumber Products in Hilo, Hawaii**

July 2023

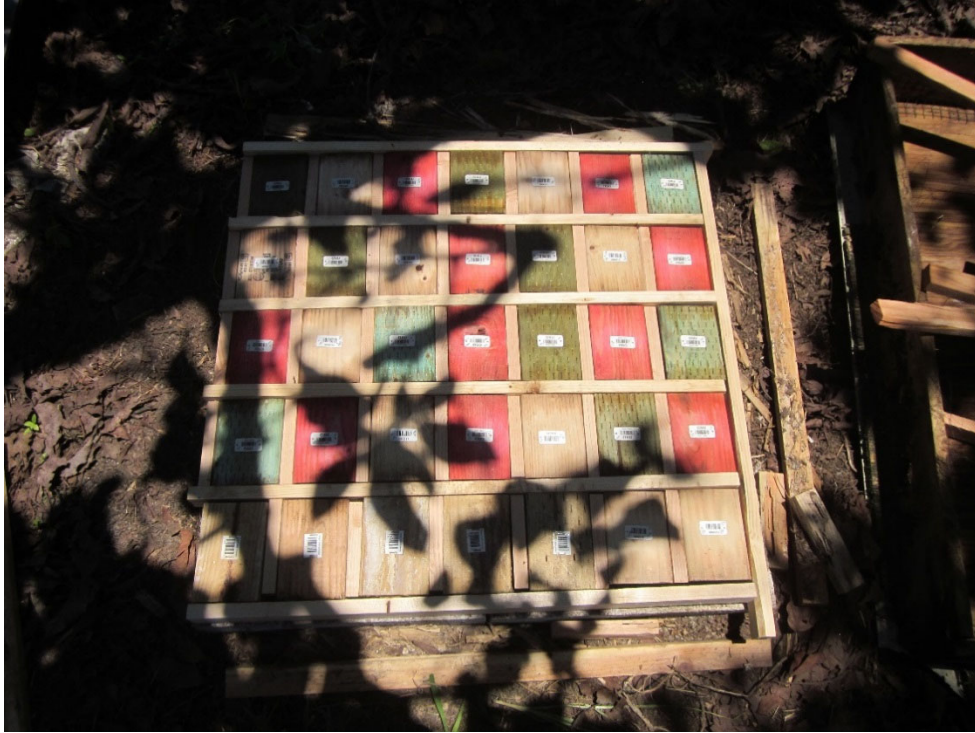
**Figure 2.** Example of a termite array with samples treated with EcoRed Shield II, HiBor or left untreated in the E26 Ground Proximity termite test after installation in June 2015.

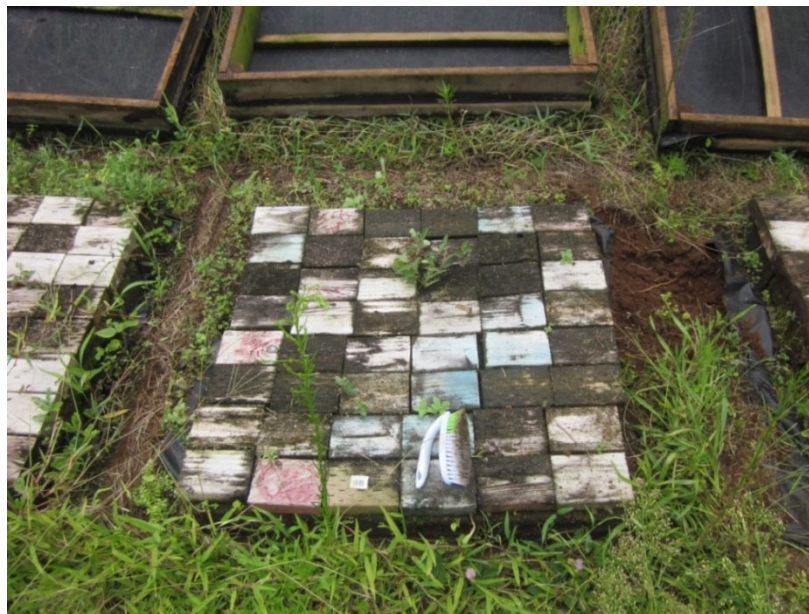
Samples exposed in the Ground Proximity test were heavily colonized by dark pigmented fungi shortly after installation, but showed no signs of fungal degradation for the first 30 months of exposure (Figures 3, 4). Untreated Douglas-fir heartwood controls had average ratings of 9.75 and 9.62 with only spots of decay on the edges of the samples after 24 and 30 months of exposure, respectively (Table 4, Figure 8). The untreated controls continued to deteriorate after 37 months of exposure and experienced more substantial decay 42 months after installation.

**Figure 3. Example of an E18 Ground proximity decay test prior to the 18-month assessment.**

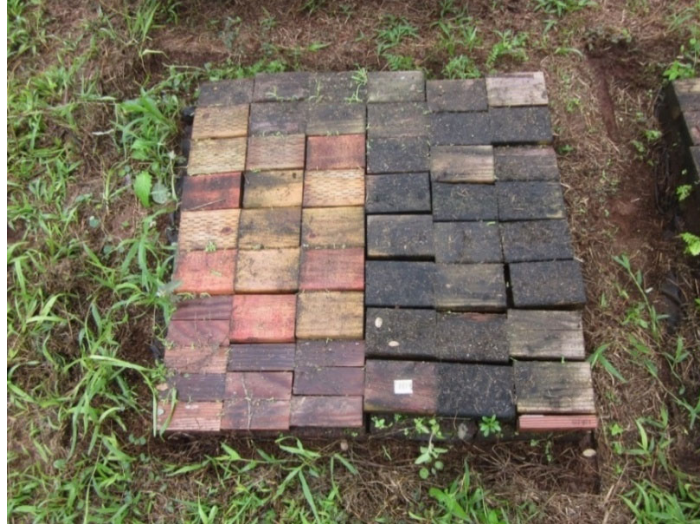
**Figure 4.** Example of an E18 Ground proximity decay test prior to the 24-month assessment for samples on the right and 6-month assessment for samples on the left. Note extensive microbial growth on the older samples.

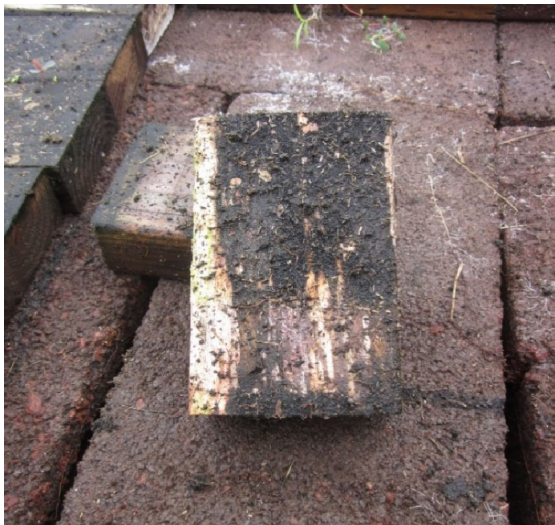
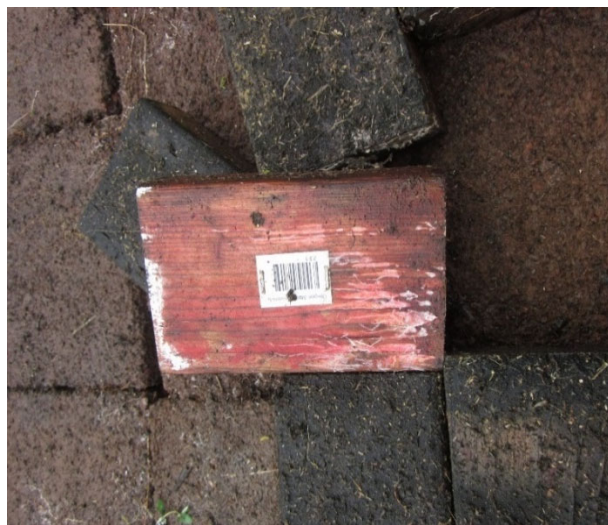
The EcoRed Shield I samples began to experience decay on the lower surfaces within 30 months of installation (Figures 5 and 8) and the levels of decay were similar to those for the non-treated controls. After 30 months, the EcoRed Shield I samples followed a trend similar to the untreated controls, although the ratings were somewhat lower than untreated wood from 48 months of exposure onwards. After 108 months, all replicate samples except for one had failed. The results indicate that EcoRed Shield I provided little to no added protection against fungal attack in this exposure.

**Figure 5.** Examples of a non-treated control (top) showing extensive surface growth and slight decay and an EcoRed Shield I sample showing white fungal growth and decay.

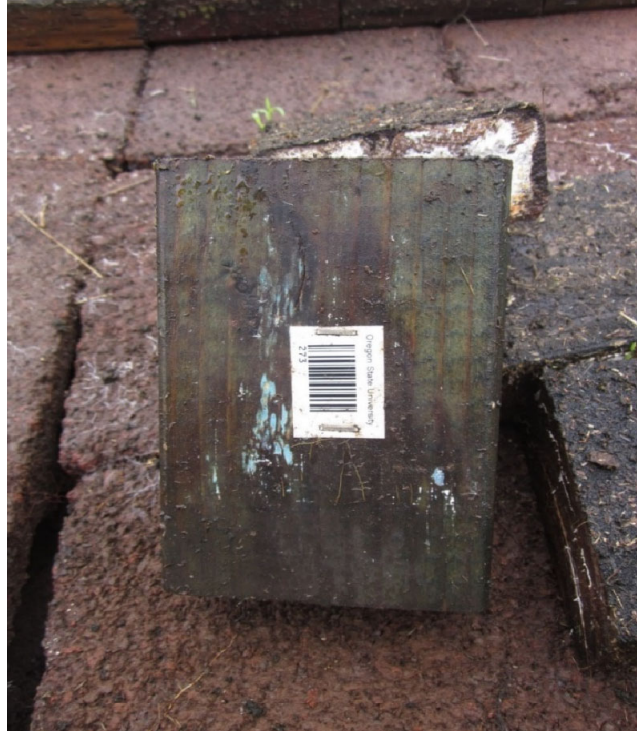
BluWood samples also followed trends similar to those for the untreated controls, with some decay evident 30 months after installation (Figure 6). The decay levels continued to increase with time and BluWood samples were only slightly different from the controls 72 months after installation. After 108 months, all BluWood samples had failed. The results suggest that BluWood provided little additional protection to timber under these exposure conditions.

**Figure 6.** *BluWood ground proximity sample after 24 months of exposure showing decay pockets with concentration of the original blue dye used to color the wood.*

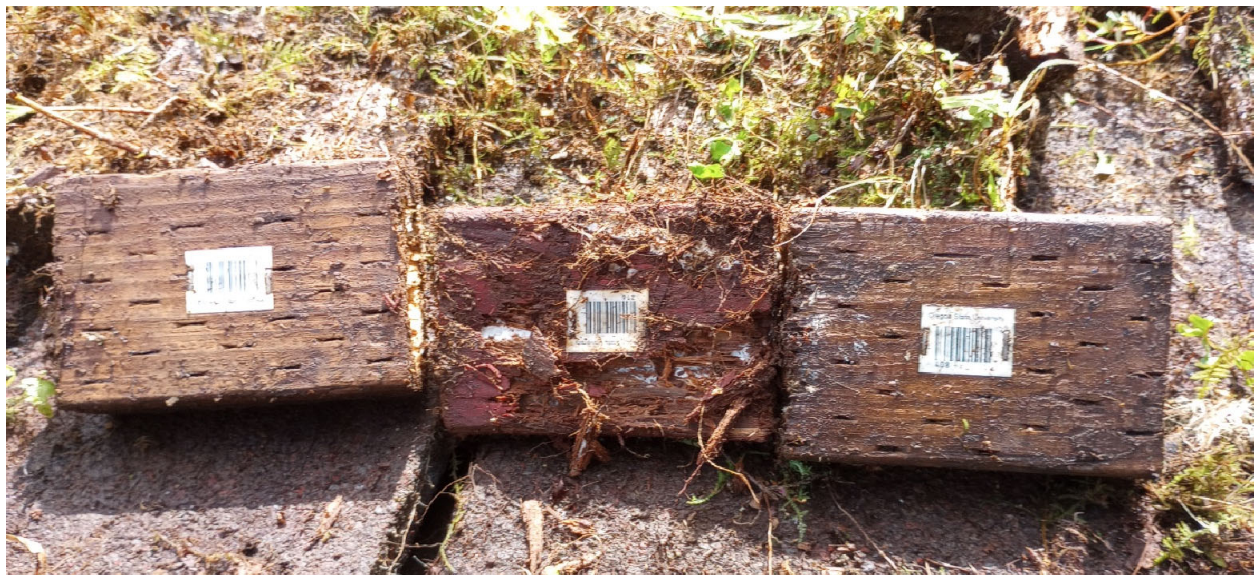
**Figure 7.** *Examples of EcoRed Shield I (middle) and Copper Azole (left and right) ground proximity samples after 108 months of exposure. The EcoRed Shield I sample pictured was the only remaining sample at this timepoint that had not failed.*

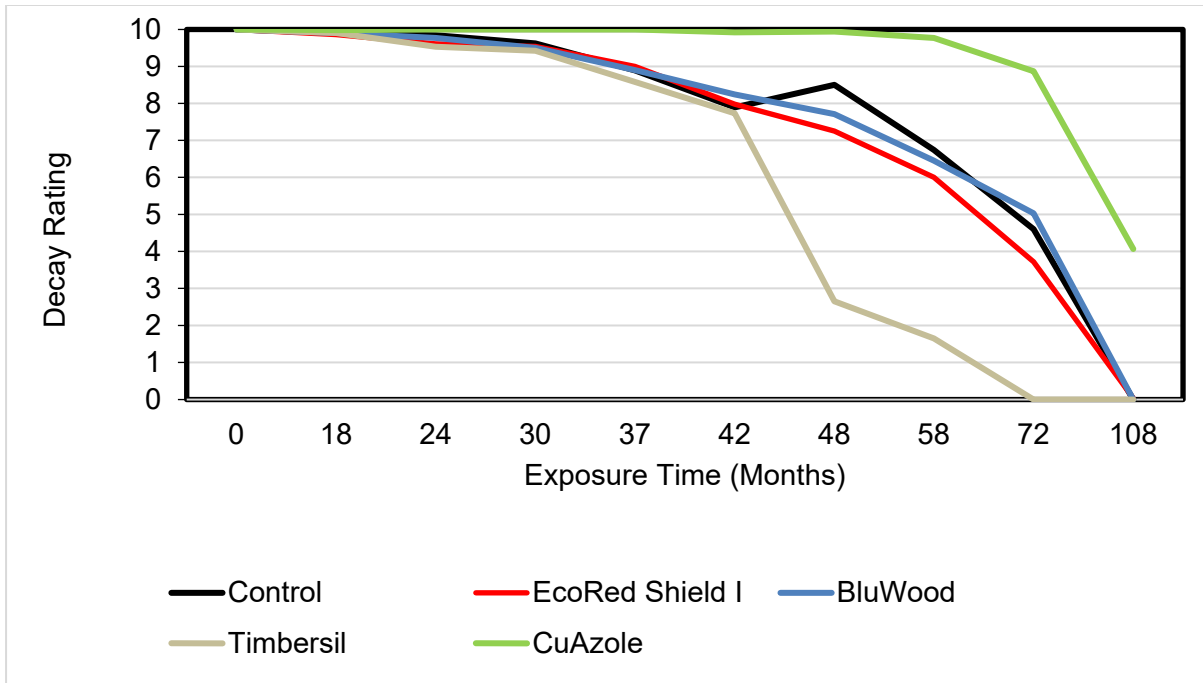
The downward trend in ratings continued over the next 30 months of exposure and ratings for the controls averaged 4.4 after a total of 72 months (Figure 8). Douglas-fir heartwood is moderately durable to decay in above ground exposures and the performance in this test is consistent with that property. After 108 months, all untreated controls in the first batch had failed and all but one control had failed in the second batch after 90 months.

**Figure 8.** Condition of untreated, EcoRed Shield I, BlueWood, Timbersil and copper azole-treated samples exposed for 108 months in a ground proximity test.

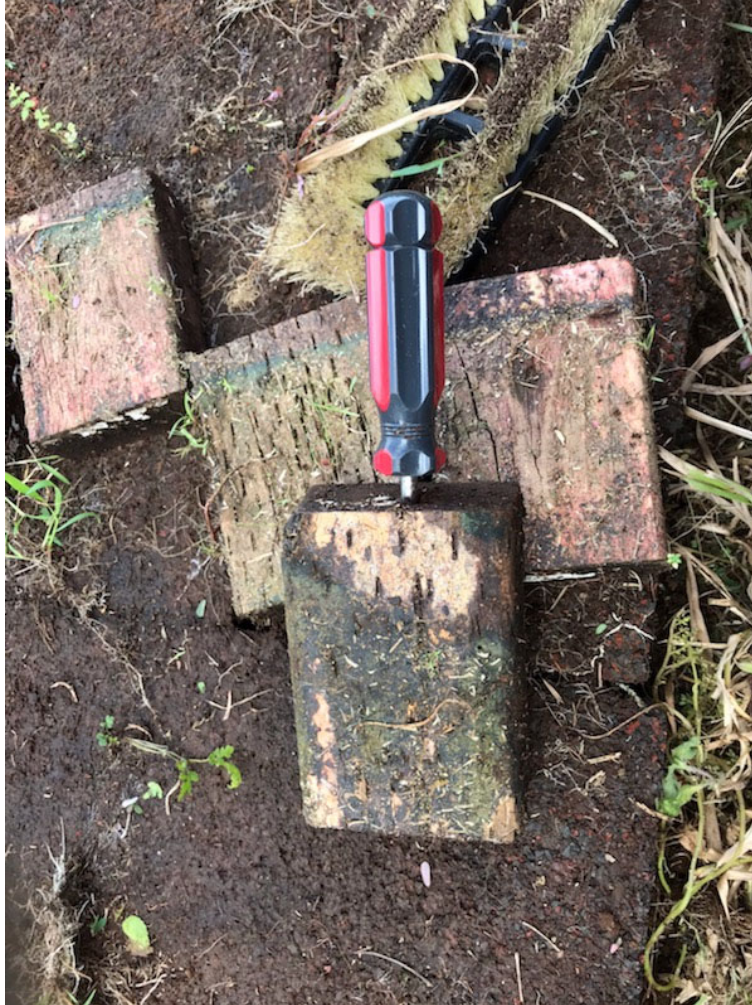
Copper azole-treated samples experienced little evidence of decay for the first 58 months, although some samples had slight evidence of decay, especially around knots or other defects. Decay was noted at the ends of some samples 72 months after installation likely due to exposure of a cut surface (Figure 9). After 108 months, average ratings had declined further to about 4 and several samples had failed at the exposed end grain.

It is important to note this decay was developing on the cut exposed ends of the timber where the initial treatment was absent. While the cut ends of each sample were briefly dipped in pentachlorophenol prior to exposure, this treatment was likely to penetrate only a short distance into the wood.

Thus, the presence of decay in the cut ends is consistent with the limited ability of end-cut treatments to retard decay under high decay hazard conditions. This in no way suggests that surface treatments of cuts exposed on treated wood not be treated, but it indicates that there is a limit to the protective effects of these shallow treatments. However, after the duration of this test, copper azole treated wood still far outperformed other treatments in this test, despite early failures caused by cutting and end treating.

**Figure 9.** *Example of a copper azole-treated ground proximity specimen showing a sound exterior but decay in the cut, exposed end grain. This effect was seen from 72 months onward.*

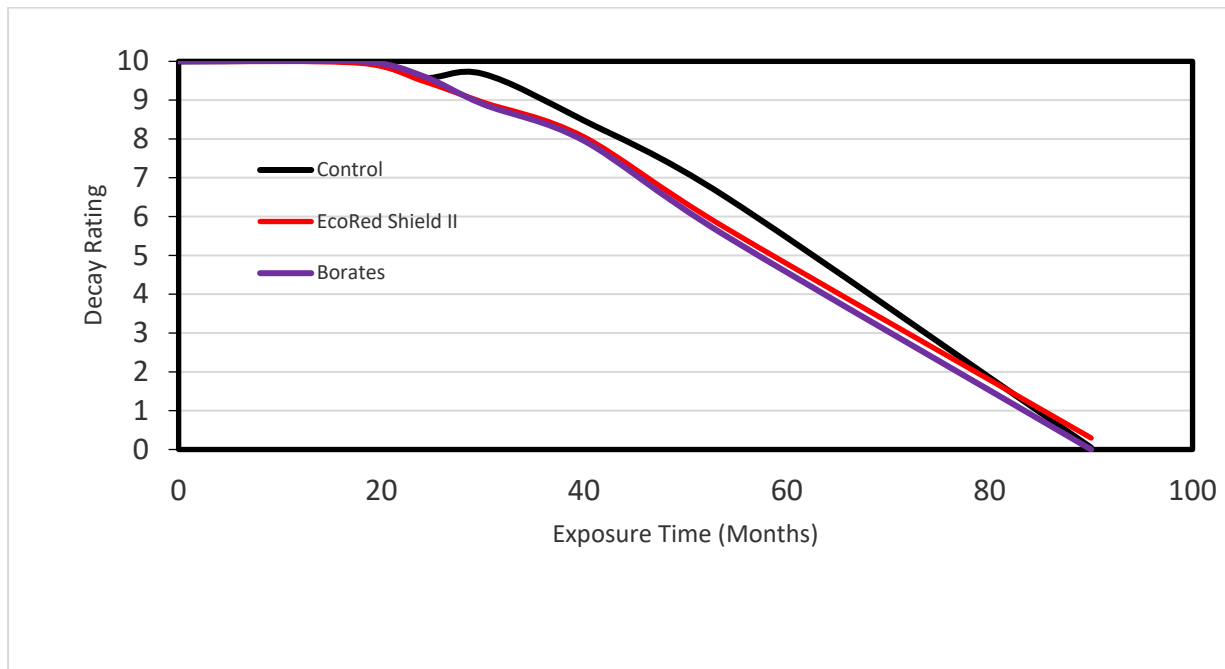
Controls set out with the second tranche of test samples performed similarly to the controls in the first tranche (Table 5 and Figure 10). EcoRed Shield II samples have also followed trends similar the controls, again suggesting that the EcoRed Shield provided little to no added protection to the wood.

HiBor treated samples were not included in the first test, but have performed similarly to the untreated controls through the duration of this test. HiBor treatment is restricted to use in above ground exposures with protection from continuous wetting. The Ground Proximity test poses an extreme wetting challenge that is outside the recommended application for this material and the results illustrate why HiBor treatment should not be used in exterior exposures.

**Figure 10. Decay ratings of untreated controls, EcoRed Shield II, and HiBor treated samples over a 90-month exposure.**

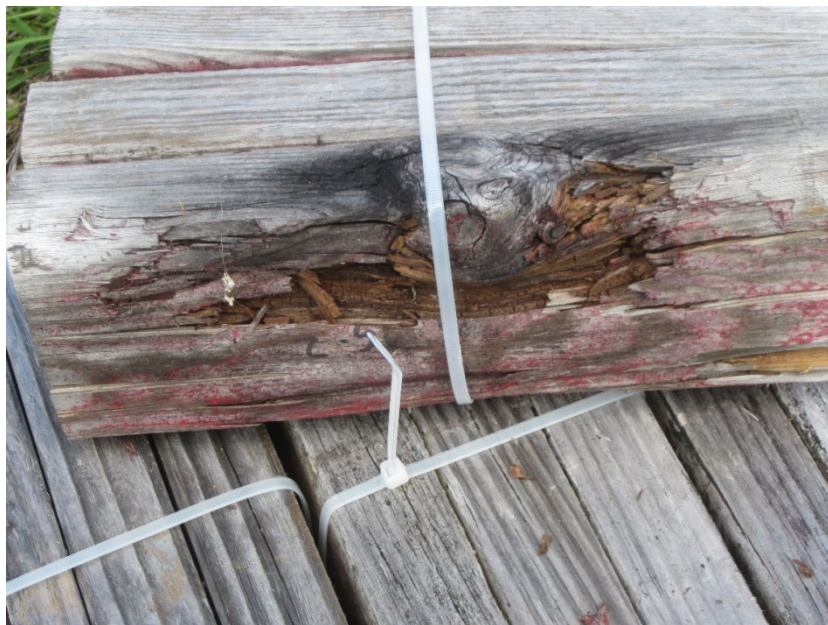
EcoRed Shield I samples experienced a gradual decline in condition over the exposure period with ratings that were generally lower (more decayed) than those for the untreated controls. In some instances, individual elements of a sandwich were close to failure after only a short time in test (Figure 9). All samples had failed the 108-month assessment (Figure 10). As with the Ground Proximity test, the results suggest that EcoRed Shield I provided little to no additional wood protection.

**Figure 9.** *Example of an EcoRed Shield I sandwich with extensive decay on the outer sample after 30 months of exposure. Interestingly, this sample remained in service through 72 months despite this early decay damage.*

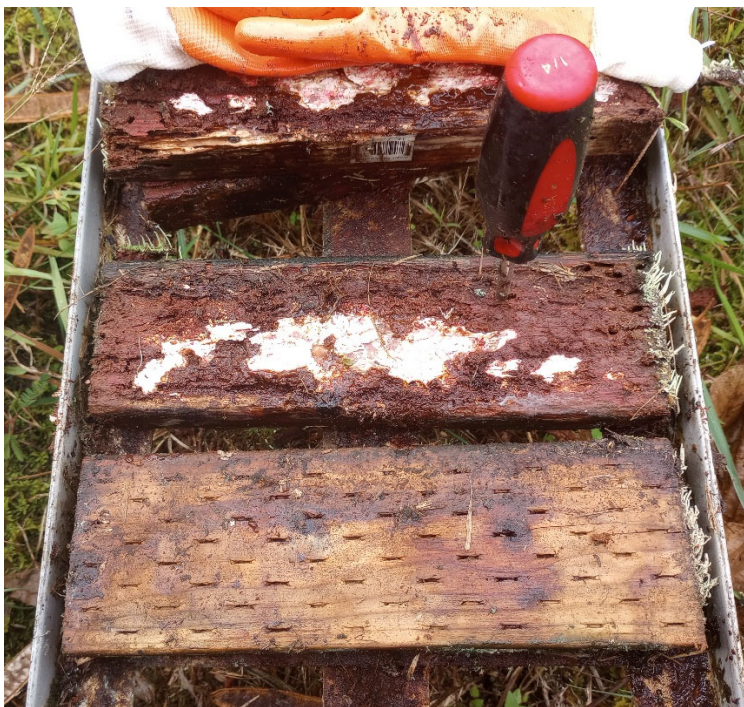
**Figure 10:** Example of sandwich test sample condition after 108 months of exposure. An EcoRed I sample is completely degraded and can be penetrated with a screwdriver, whereas a copper azole-treated sample at the bottom of the photo is in much better condition.

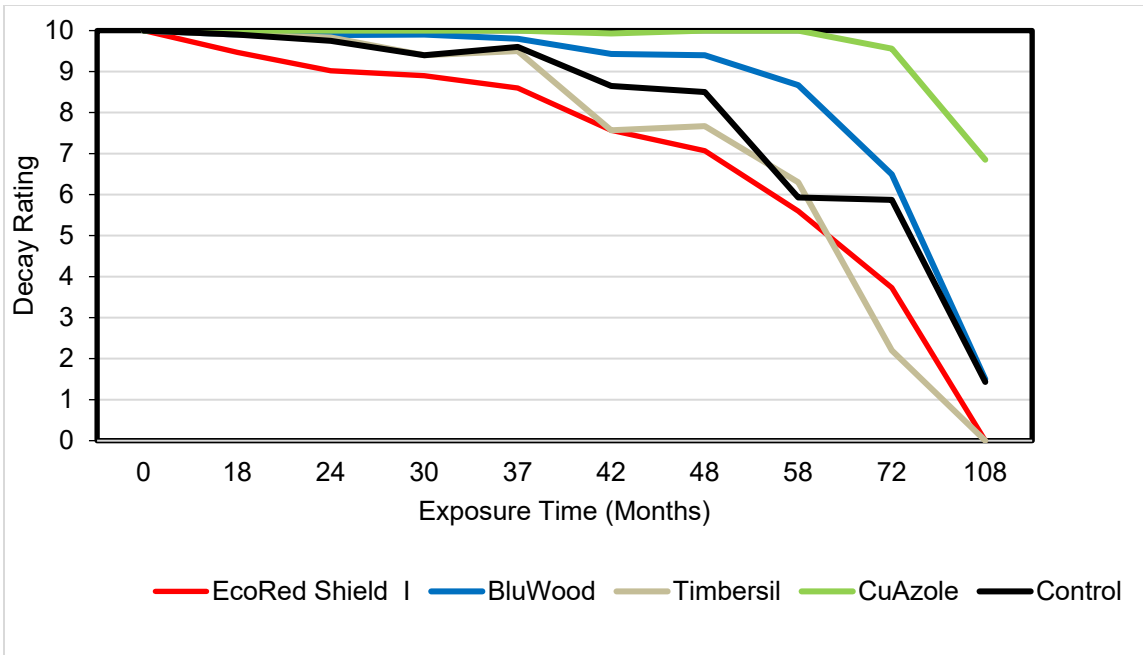
**Figure 10.** Average Decay ratings for untreated, EcoRed Shield I, BluWood, Timbersil and copper azole-treated samples exposed for 108 months in a sandwich test.

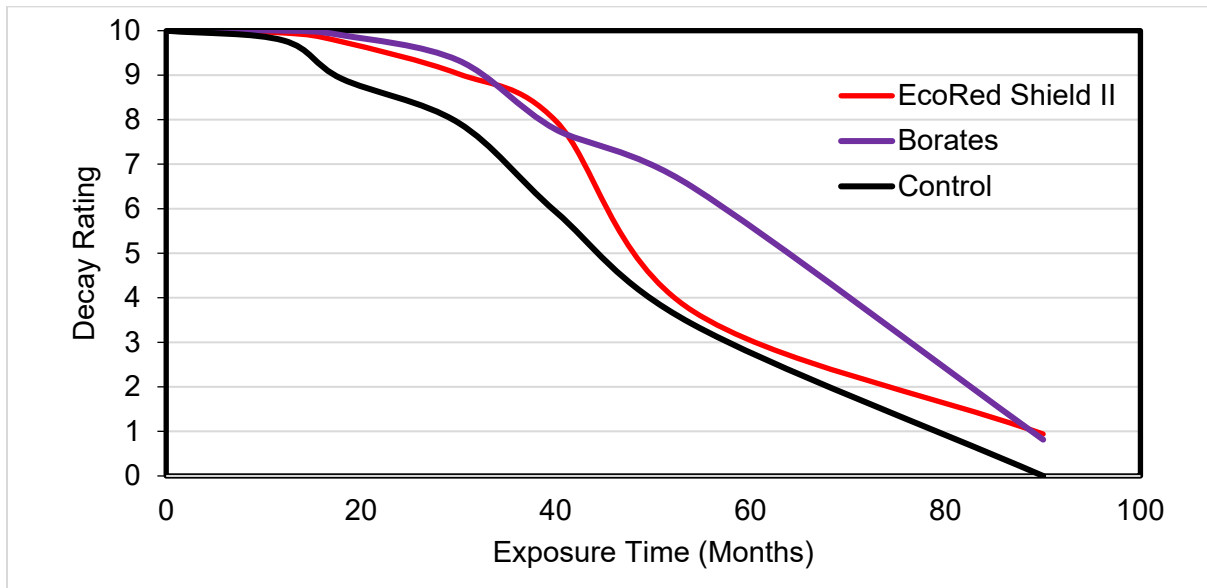
Sandwiches exposed in 2015 had slight evidence of decay after 18 months of exposure and decay ratings continued to decline after 30 months (Table 7). Decay ratings also declined on EcoRed Shield II samples at rates that were similar to those for the EcoRed Shield I. EcoRed Shield II and control samples had similar ratings at 54 months, suggesting the treatment provided little added protection. After 90 months, nearly all of the EcoRed Shield II samples had failed.

HiBor treated samples exhibited little evidence of decay for the first 30 months of exposure, but then decay became evident on some samples. While HiBor treated samples were beginning to decay, the samples were still in relatively good condition 54 months after installation. At the 90-month assessment, borate-treated samples had taken a dramatic turn for the worse and the majority of the samples had failed.

**Figure 11.** Decay ratings for untreated, EcoRed Shield II and Hi-Bor samples exposed for 90 months in a sandwich test.
