**Condition of Chromated Copper Arsenate Treated Hem-fir Guardrail Posts after
20 Years in Service in Western Washington State**

A Final Report Submitted To

Western Wood Preservers Institute

November 2012

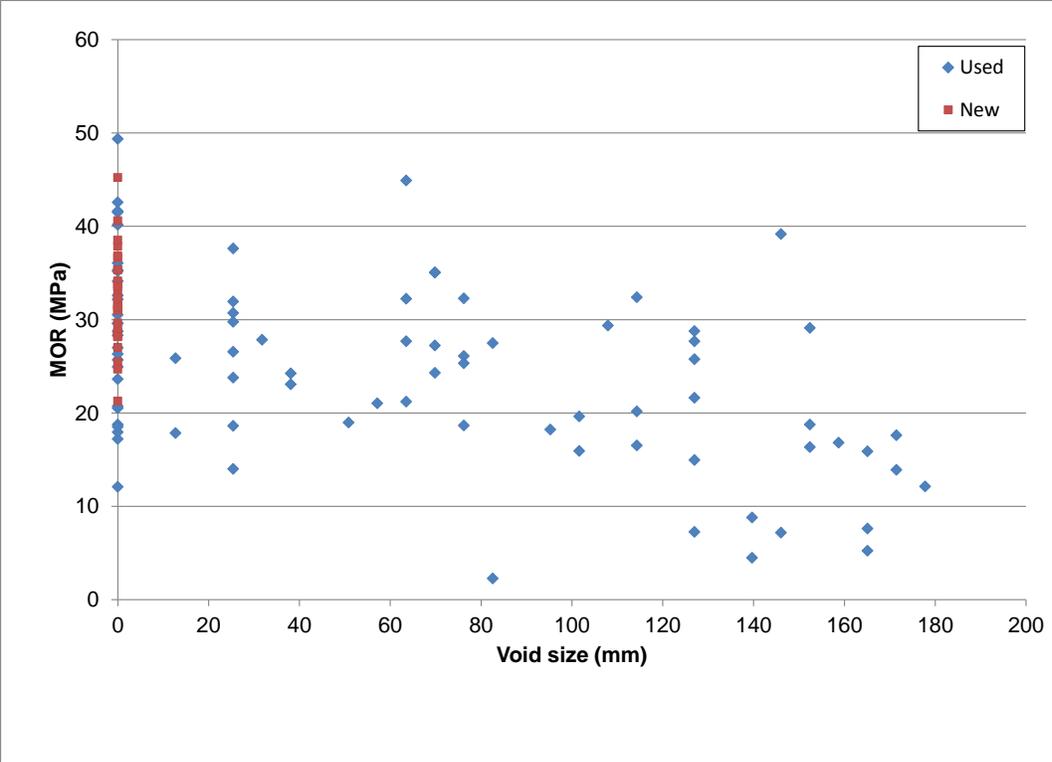
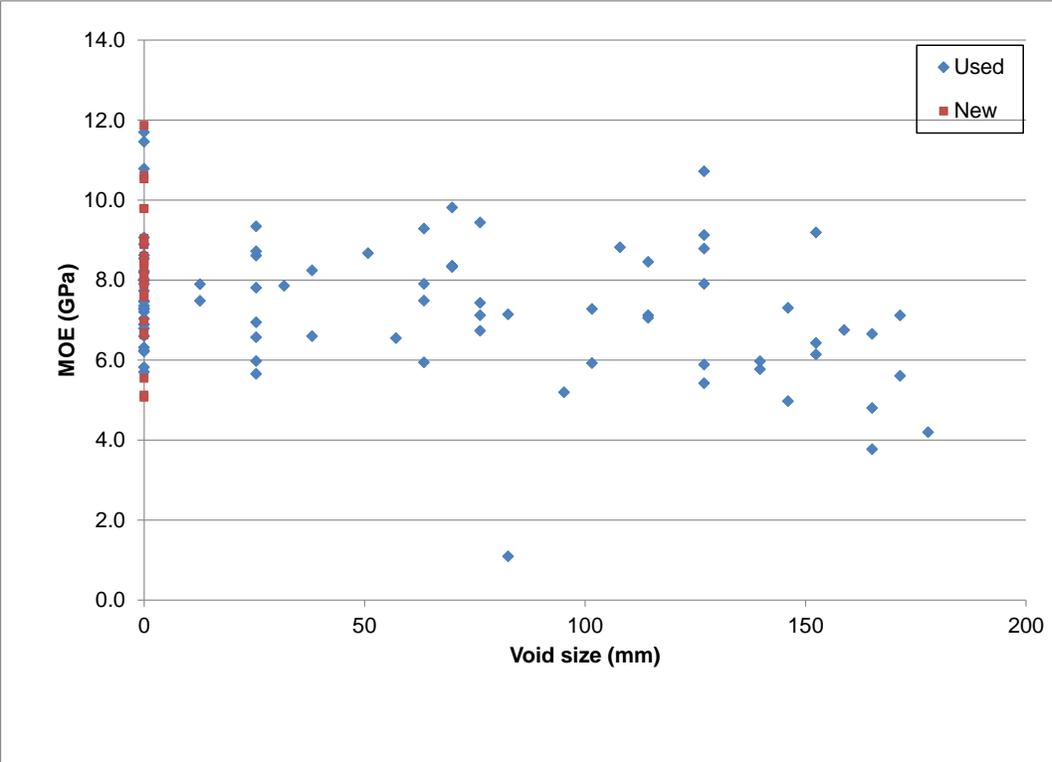
Figure 4. Scatter plots of (a) MOR and (b) MOE vs. void size in new and used CCA treated hem-fir guardrail posts.

Freshly treated guardrail posts had an average MOR of 32.17 MPa and an average MOE of 7.91 GPa (Table 2). These values are slightly lower than those reported for hem-fir in the USDA Wood Handbook (USDA, 2010). The differences reflect both the nature of the test and the small population size. The test method produced an asymmetric load on the post in order to force the failure through a zone about the intended groundline. This was necessary because the in-service posts were tested to bring the maximum loading to the area that had been subjected to the highest risk of decay (the groundline). Thus, the results for the new posts should only be used as a comparator for the materials removed from service. The posts had a normal distribution around 34.5 MPa. The overall distribution of MOR values was also normal for used posts, but it had shifted downward slightly as a result of the presence of voids in some posts. Scatter plots of these data indicated that many posts still retained excess capacity (Fig. 4). The mean value for guardrail posts after 20 years of service was 24.45 MPa and 7.35 GPa for MOR and MOE, respectively. While the MOR of the new and used guardrail posts were significantly different ($p < 0.01$, 2 sample t-test), no statistical difference ($p > 0.05$, t-test) was observed in the MOE values. This was expected since MOE is the wood property that is least affected by exposure to property degrading mechanisms (MacLean 1953, Sinha et al. 2011). Further, there was a significant decrease in MOR values as void size increased ($p < 0.05$, ANOVA) as observed in Fig. 4. Increased void sizes were associated with significantly lower MOE values ($p < 0.05$).

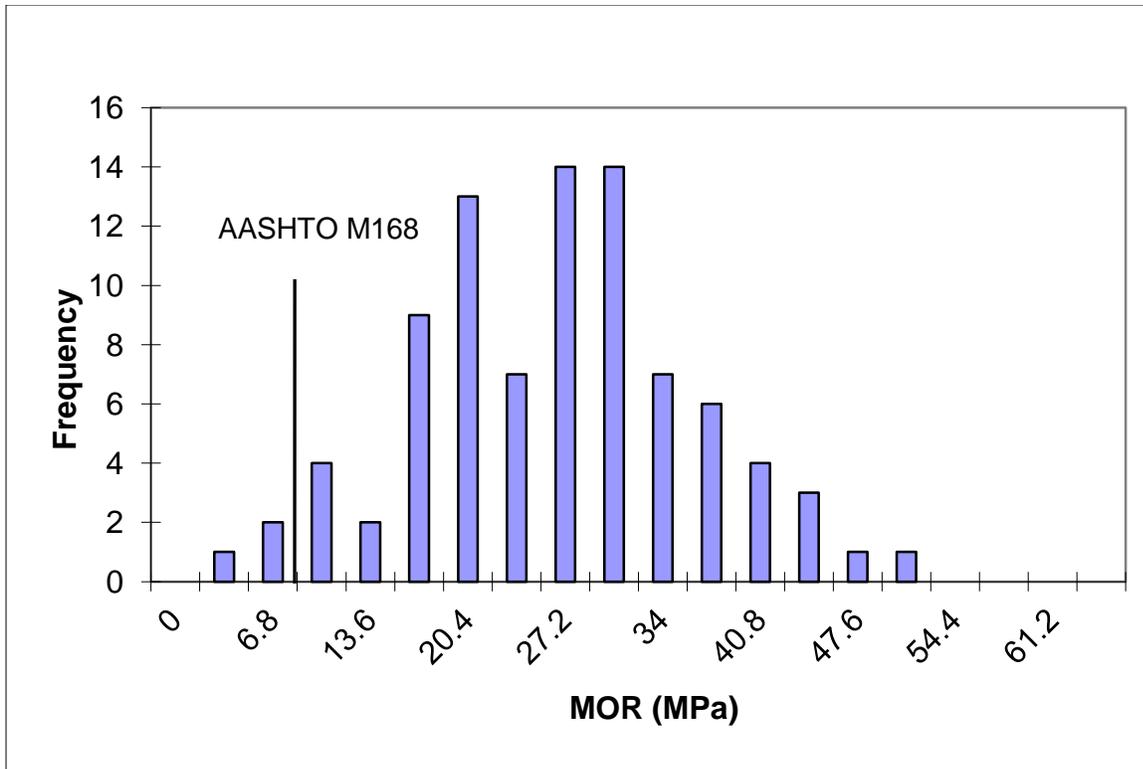
Figure 5. Distribution of Modulus of Rupture (MOR) values in a population of 84 posts that had been in service for 20 years that were tested to failure in fourth point loading. The line at 9 MPa denotes the AASHTO minimum strength criteria for the highest stress grade of Hem-Fir for guardrail posts.

Structural Hem-Fir). These results illustrate the high residual capacity present in guardrail material at the time of installation. Fig. 5 presents the frequency distribution for MOR values of used posts. The AASHTO recommended value of 8.2 MPa for Hem-Fir is also marked for comparison (AASHTO 2007). All but three (3) posts exceeded the maximum design value of 8.2 MPa (Fig. 4a). Grades No.1 and No.2 are widely used lumber grades and select structural grade is seldom used in practice for guardrail posts applications. Previous research (e.g., Atahan et al. 2002) reported an average MOR for wooden guardrail posts of 3 MPa, which was lower than the results observed in this study. The differences may be due to the different test methods in the current study compared with the static center-point bending used by Atahan et al. (2002).
